Manhole Inspection Summary

Manhole # S39GG_037MH

Insp Date: **3/28/07 12:19 PM**

Location Address: **1309 HILLMAN ST**

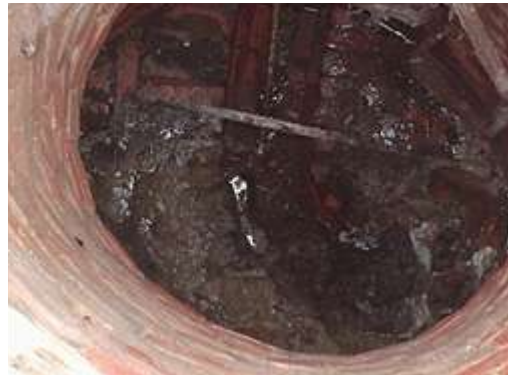
Top View

Corroded steps. Evidence of surcharge - Bench debris. Channel debris.

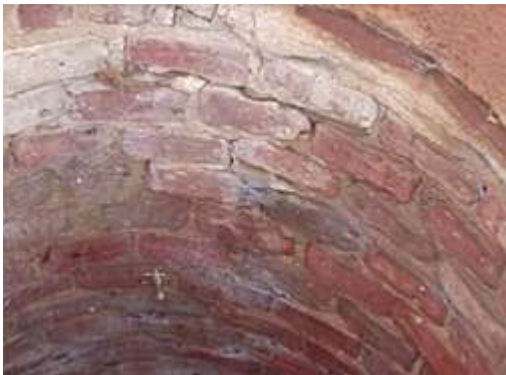
Defect

Frame leaks. Adjustment and Corbel deterioration and infiltration.

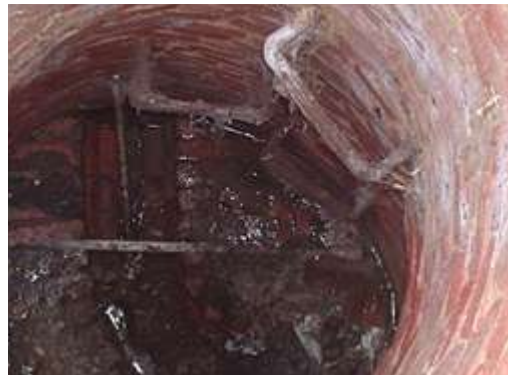
Defect

Adjustment, Corbel and Barrel infiltration.

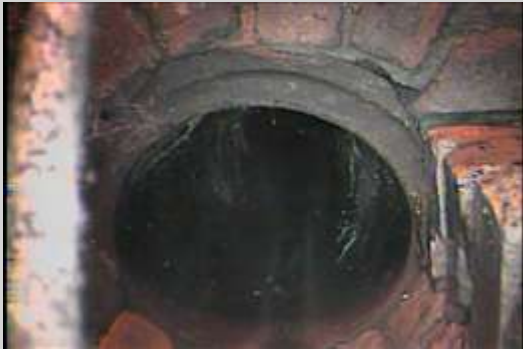
8 in. Circular Gravity Sewer Pipe Out @ 12 O'Clock

Infiltration: **Evidence** Pipe Seal Cond: **Unknown**

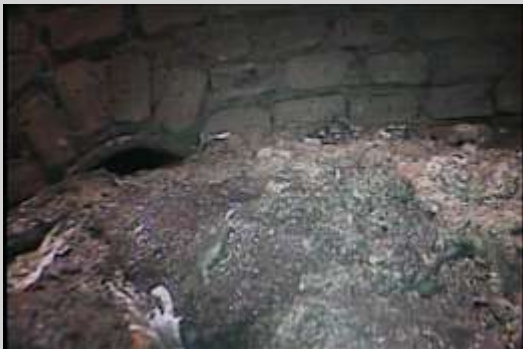
8 in. Circular Gravity Sewer Pipe In @ 3 O'Clock

Deposits: ☐ None ☐ Mud ☐ Sludge ☒ **Debris** ☐ Grease

Silt Depth: **7** (in.) Deposits Extent: **Heavy**

Infiltration: **Evidence** Pipe Seal Cond: **Unknown**
